**Integrated Pest Management (IPM) in
Museums, Archives and Historic Houses -
Proceedings of the International
Conference in Vienna, Austria 2013**

Distribution of wooden-damaging beetles captured by adhesive traps in historic buildings in

Hayashi, Mikiko; Kigawa, Rika; Harada, Masahiko; Komine, Yukio; Kawanobe, Wataru & Ishizaki, Takeshi

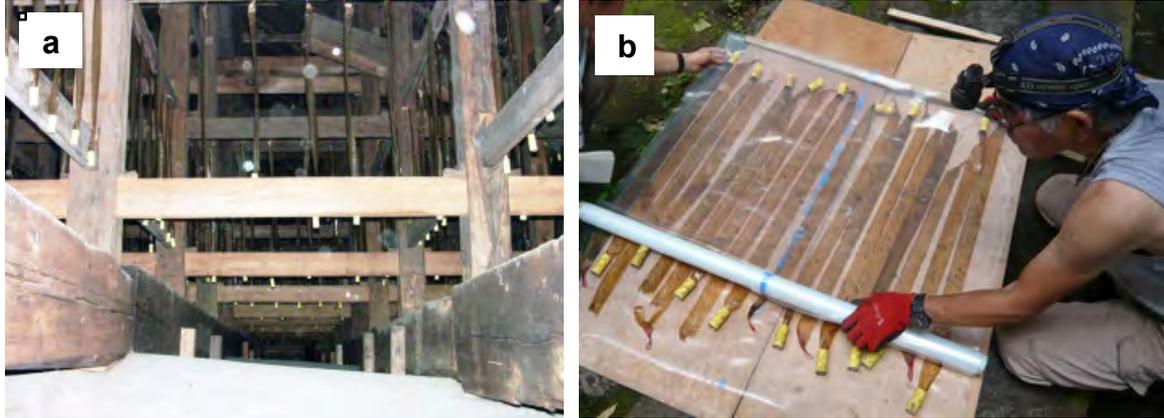
Fig. 1: Setting and removing adhesive traps for anobiid beetles at the Nikko World Heritage Site. **a**: Adhesive traps set in the loft space under the roof. **b**: Adhesive traps collected on one sheet.

The adhesive traps were commercial products that are usually used to catch flies. About 27,000 adhesive traps (width: 4 cm; length: 78 cm, Daiso Industries, Hiroshima, Japan) were placed in the loft and basement spaces of 72 wooden buildings at the Nikko site from the end of April to the beginning of October 2010 over a 5-month period. This time of year is warm enough that adult insect emergence can be observed. The association for the Preservation of the Nikko World Heritage Site Shrines and Temples placed and removed the adhesive traps (Fig. 1a) (Harada *et al.* 2011). Adhesive traps were positioned at near regular intervals. Counting and identification were originally to have been done on the spot. However, there was not enough light in the lofts and basement spaces to count the insects, and it was difficult to identify the insects precisely in the dark and confined conditions. About twenty adhesive traps at a time were sandwiched between two sheets of polyethylene and were sent to the National Research Institute for Cultural Properties, Tokyo (NRICPT) for the identification and counting of species (Fig. 1b).

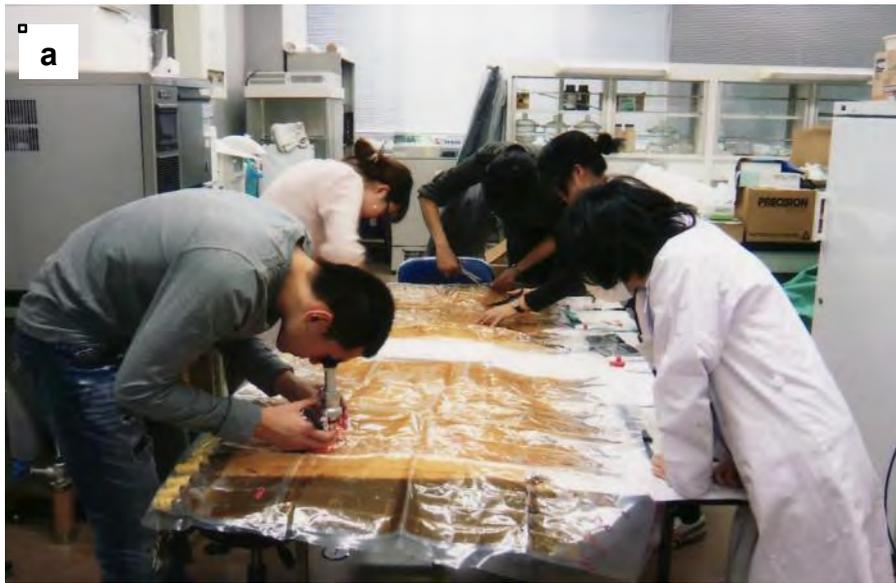
The front and the back of each sheet of adhesive traps were scrutinized using a hand microscope (Fig. 2a). Trapped beetles were circled with an oil-based red pen, and photos were taken as a record. The beetles were then counted and cut off from the sheets. The beetles on a given adhesive trap were grouped and identified. These processes were conducted with data tabulation sheets to ensure that the location of the traps and numbers of beetles were recorded (Fig. 2b). Many types of insects such as spiders, ants and dragonflies were present on the adhesive traps, but this survey targeted only the insects that cause damage to wood. Wood-boring anobiids had been reported in Rinnohji Temple the year before the large-scale survey, and these were identified and quantified by the survey. The counting and identification were carried out from the end of July to the beginning of December in 2010.

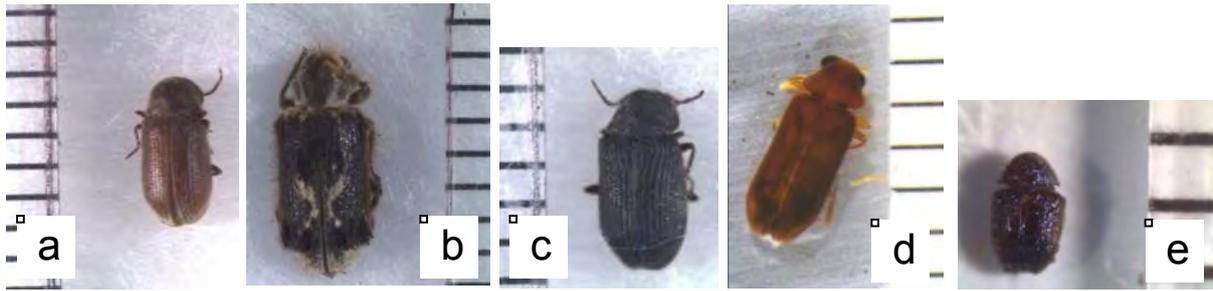
Fig. 3: Wood-boring anobiids found in the Nikko area (Komine *et al.* 2011). a: *Priobium cylindricum*. b: *Trichodesma japonicum*. c: *Hadrobregmus pertinax*. d: *Oligomerus japonicas*. e: *Sculптоtheca hilleri*.

Five types of wood-boring anobiids were found throughout the Nikko site: *P. cylindricum* (Fig. 3a), *Trichodesma japonicum* (Fig. 3b), *Hadrobregmus pertinax* (Fig. 3c), *Oligomerus japonicas* (Fig. 3d), and *Sculptothecha hilleri* (Fig. 3e). *P. cylindricum*, *T. japonicum*, *H. pertinax* and *O. japonicas* are large anobiids compared to *S. hilleri*. Large anobiid species can cause significant damage to wood.

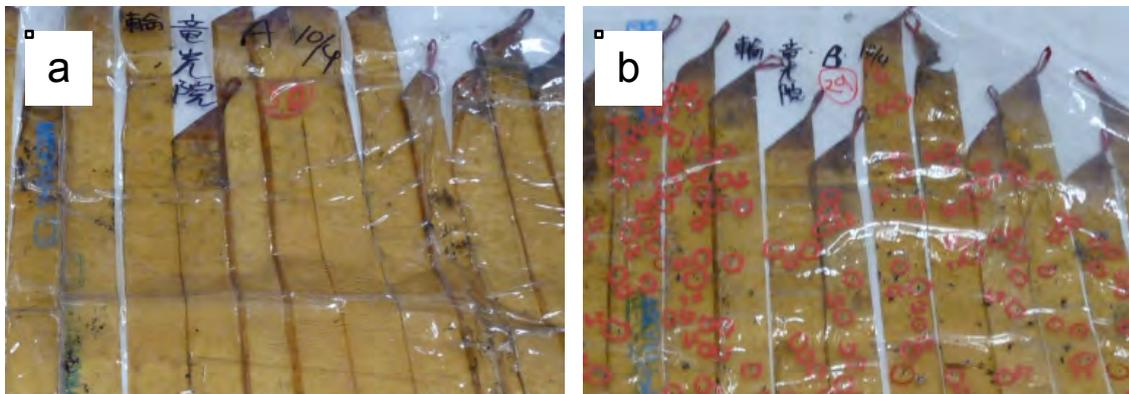
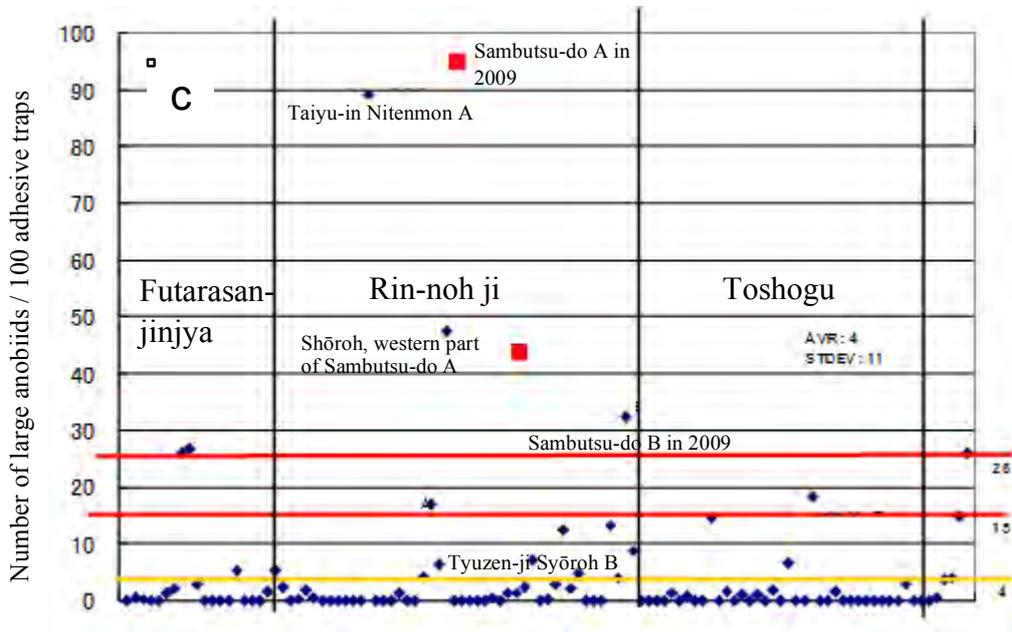
Fig. 4: Relative evaluation for total counts. a: Loft space under the roof, and b: basement space under the floor in Taiyu-in Bettoshō Ryukoh-in. c: The number of large anobiids number per 100 adhesive traps.

However, even when the numbers of adhesive traps are not the same or equivalent, a relative evaluation is necessary to compare the damage to the various wooden structures. We focused here on the number of large anobiids because the damage from large anobiids was expected to be more severe than the damage from small ones. To compare the numbers of large anobiids, we calculated and plotted the large anobiids number per 100 adhesive traps (Fig. 4c). The numbers of large anobiids in the Sambutsudo and Nitenmon were significant, and based on this finding we confirmed that precise surveys of each historic wooden building were necessary.

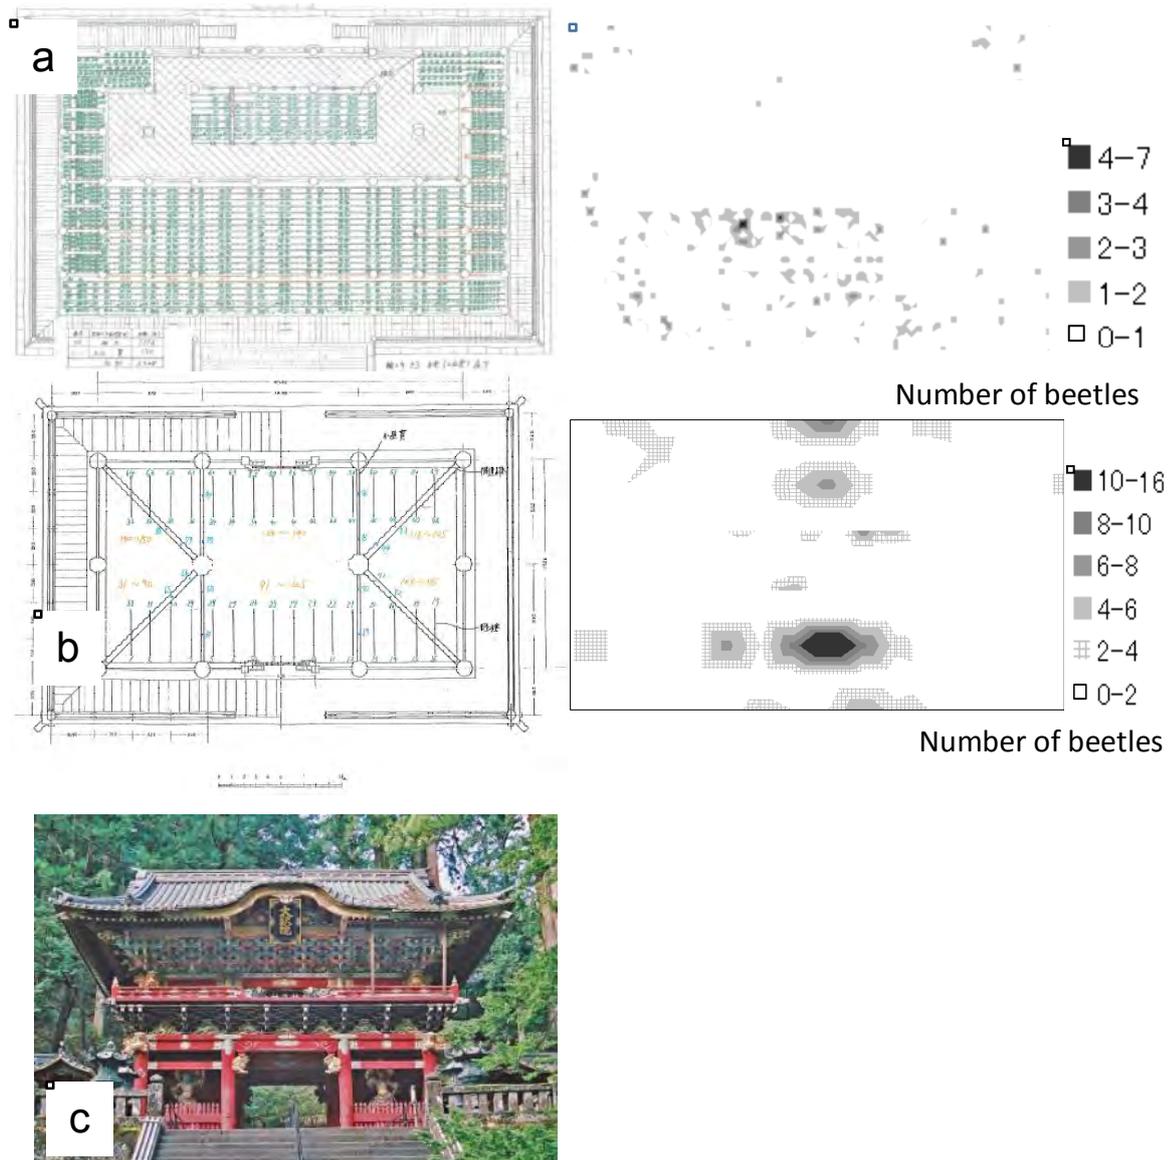
Fig. 5: Distribution of beetles in the Sambutsudo and the Nitenmon. **a**: The distribution in the Sambutsudo. **b**: The distribution in the Nitenmon. **c**: The outside of the Nitenmon.

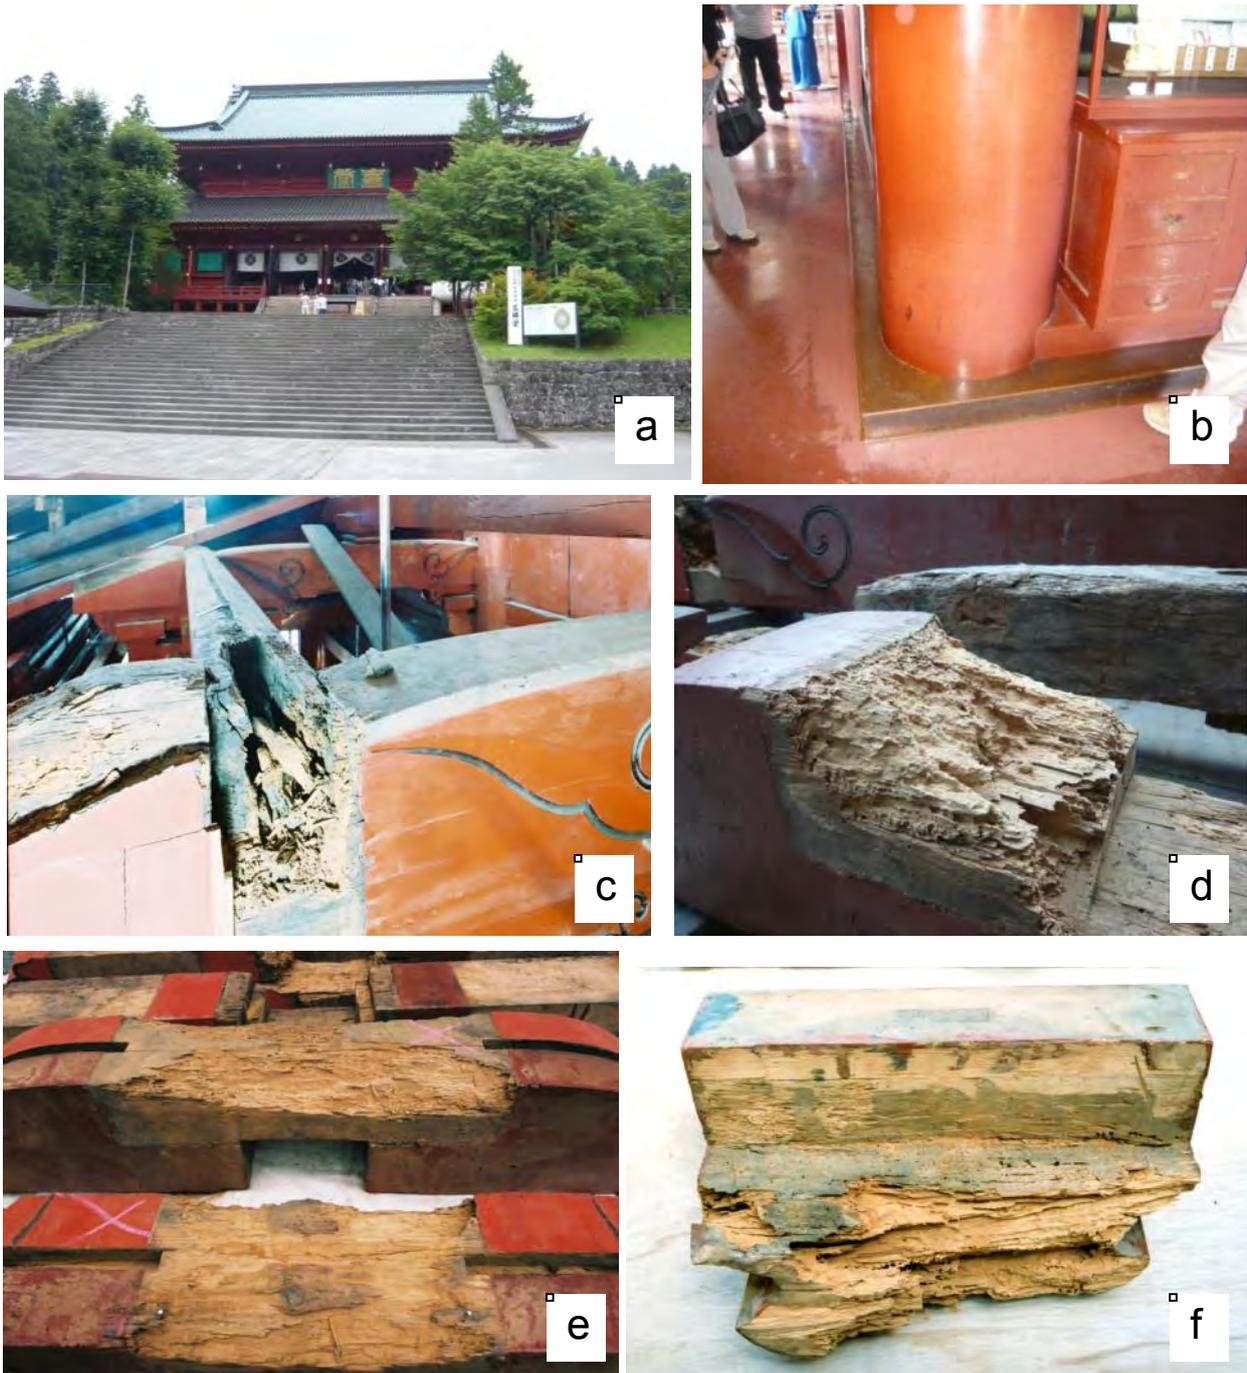
Fig. 1: The Sambutsu-do building of Nikko-zan Rin-nohji Temple and the damage by the anobiid *P. cylindricum*. **a**: Outside view of the Sambutsu-do. **b**: An example of one of the huge columns in the Sambutsu-do, approx. 16 m long, painted with a thick layer of red urushi. **c-f**: Examples of the damage by *P. cylindricum*.

A very rare type of insect damage was found by chance during a small restoration project at the Sambutsu-do of Rin-nohji Temple (Fig. 1a) in June 2008. Heavy damage was observed in 22 of 30 wooden parts which were supporting the weight of the building's lower roof. The hard heartwood, which is not usually damaged even by termites, was severely damaged to a powdery state, and the wood parts had completely lost their physical strength (Fig. 1c–f). The carpenters were surprised to find unexpected severe damage inside the beams and other pieces, especially at the wood joints. The damage had different characteristics compared to the damage that is usually observed, such as that caused by *N. hirtum*. The carpenters said that they had never seen such severe and peculiar damage. The damage was not easily detected by observations from the outside of the building, as it is coated with a thick red layer of urushi, a natural laquer originated from urushi tree sap (Fig. 1a,b).

Yukio Komine (one of the authors) and Katsuji Yamano examined a damaged piece (Fig. 1f) and they found one adult insect (Fig. 2c) from the piece. They identified the insect as *Priobium cylindricum* (Komine *et al.* 2009). We collected and observed the insect larvae from damaged wood; the larvae became pupae (Fig. 2d, right) and adults of *P. cylindricum*.

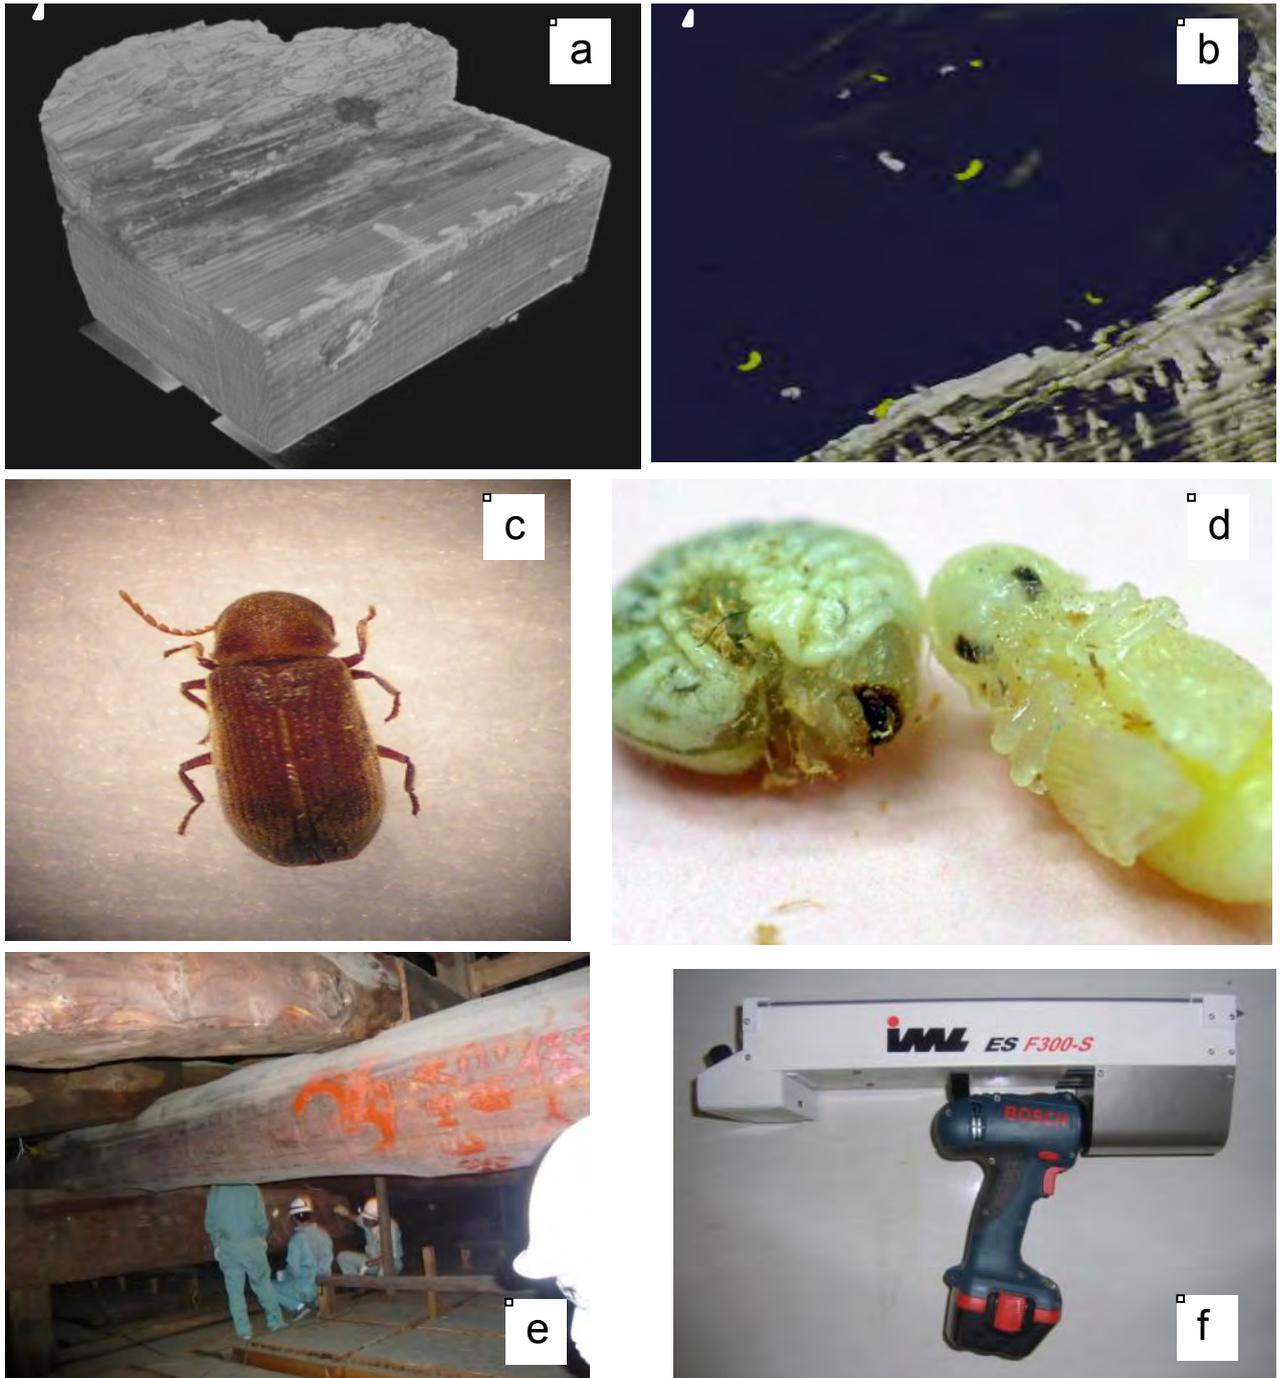
Fig. 2: Survey of insect damage by X-ray CT scanning and the Resistograph drilling resistance instrument. **a, b**: X-ray CT scanning of a damaged wooden piece from the Sambutsu-do. The larvae's positions changed over a 5-day interval (indicated in white and yellow), demonstrating that the larvae were active (Torigoe *et al.* 2010). **c**: *P. cylindricum* adult emerged from a damaged wooden block. **d**: A larva and a pupa of *P. cylindricum*. **e, f**: Resistograph and a survey of physical strength with it (Fujii *et al.* 2009).

The carpenters initially considered the infestation inactive because they did not observe any insects when they found the damaged pieces at wood joints (Harada *et al.* 2010). However, X-ray CT scanning of damaged wooden pieces performed at the Kyushu National Museum clearly showed that many larvae were inside the pieces (Kigawa *et al.* 2009). The larvae were confirmed to be active by repeated X-ray CT scanning observations over a 5-day interval, as the positions of the larvae changed (Fig. 2a,b) (Torigoe *et al.* 2010).

As the damage to larger areas in the Sambutsu-do became obvious, it was necessary to appraise the level of physical strength - especially of structurally important wooden parts of the building. Authors Y. Fujii and Y. Fujiwara of Kyoto University and responsible staff conducted surveys using a Resistograph drilling resistance instrument (IML-RESI F300, IML, Orange Park, FL, USA) (Fig. 2e,f). This instrument is used to determine the resistance value of wood when its thin drill bit is drilled into the wood. The resistance is a measure of the wood's physical strength.

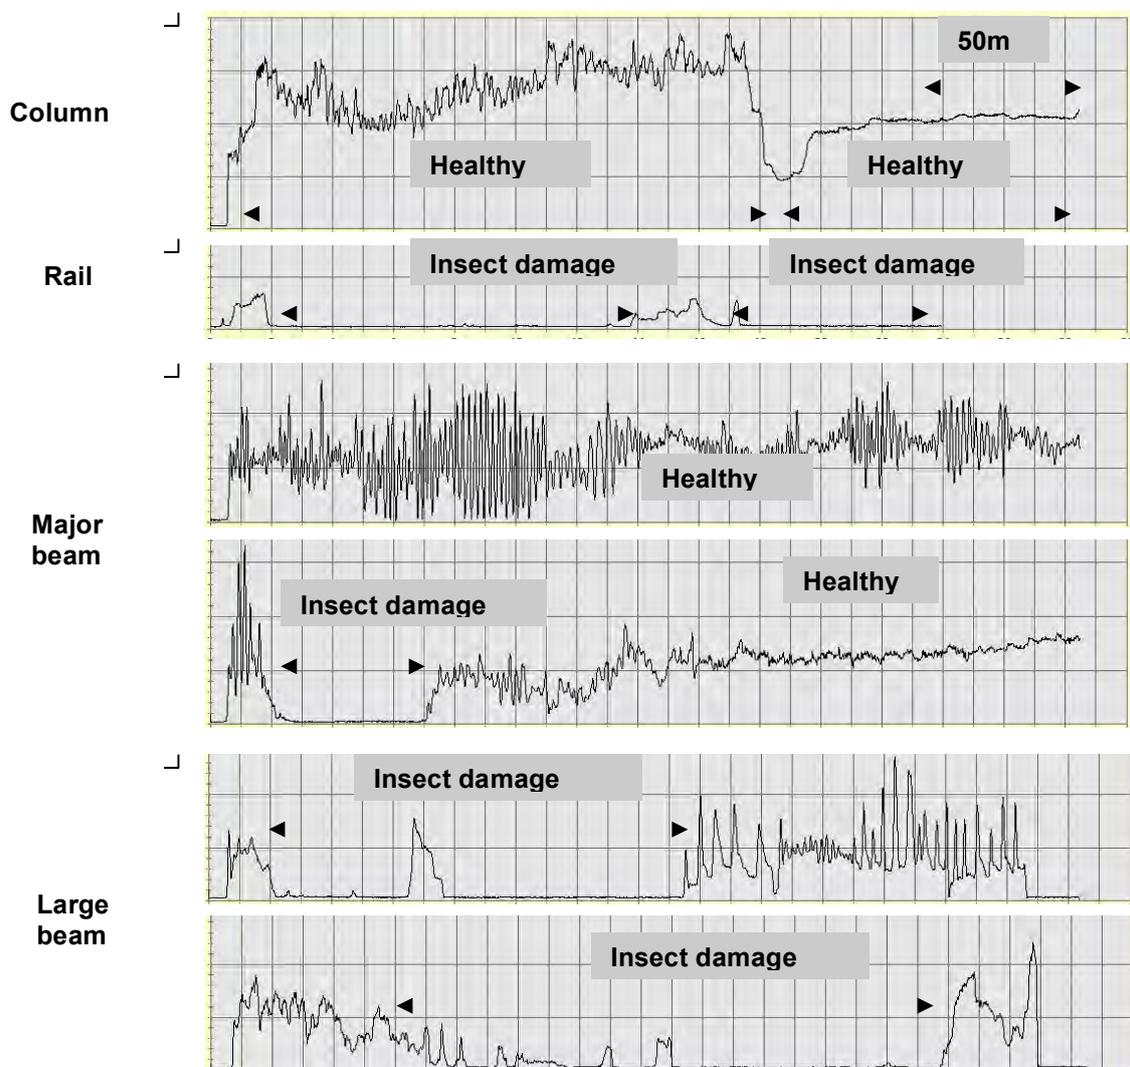
Fig. 3: Examples of the results of the Resistograph survey (Fujii *et al.* 2009).

It was found that the physical strength of some important structural beams was significantly lost due to the insect damage. As shown in Fig. 3, at the sites of insect damage the resistance value was quite low (Fujii *et al.* 2009). The carpenters tied one of the damaged large beams to the ceiling with cables as it was in danger of falling down at any time. Beneath the beam are three enormous wooden Buddha sculptures (Sam-but-su). Based on the results of this survey, it was decided that a large-scale restoration of the Sambutsu-do building was necessary.

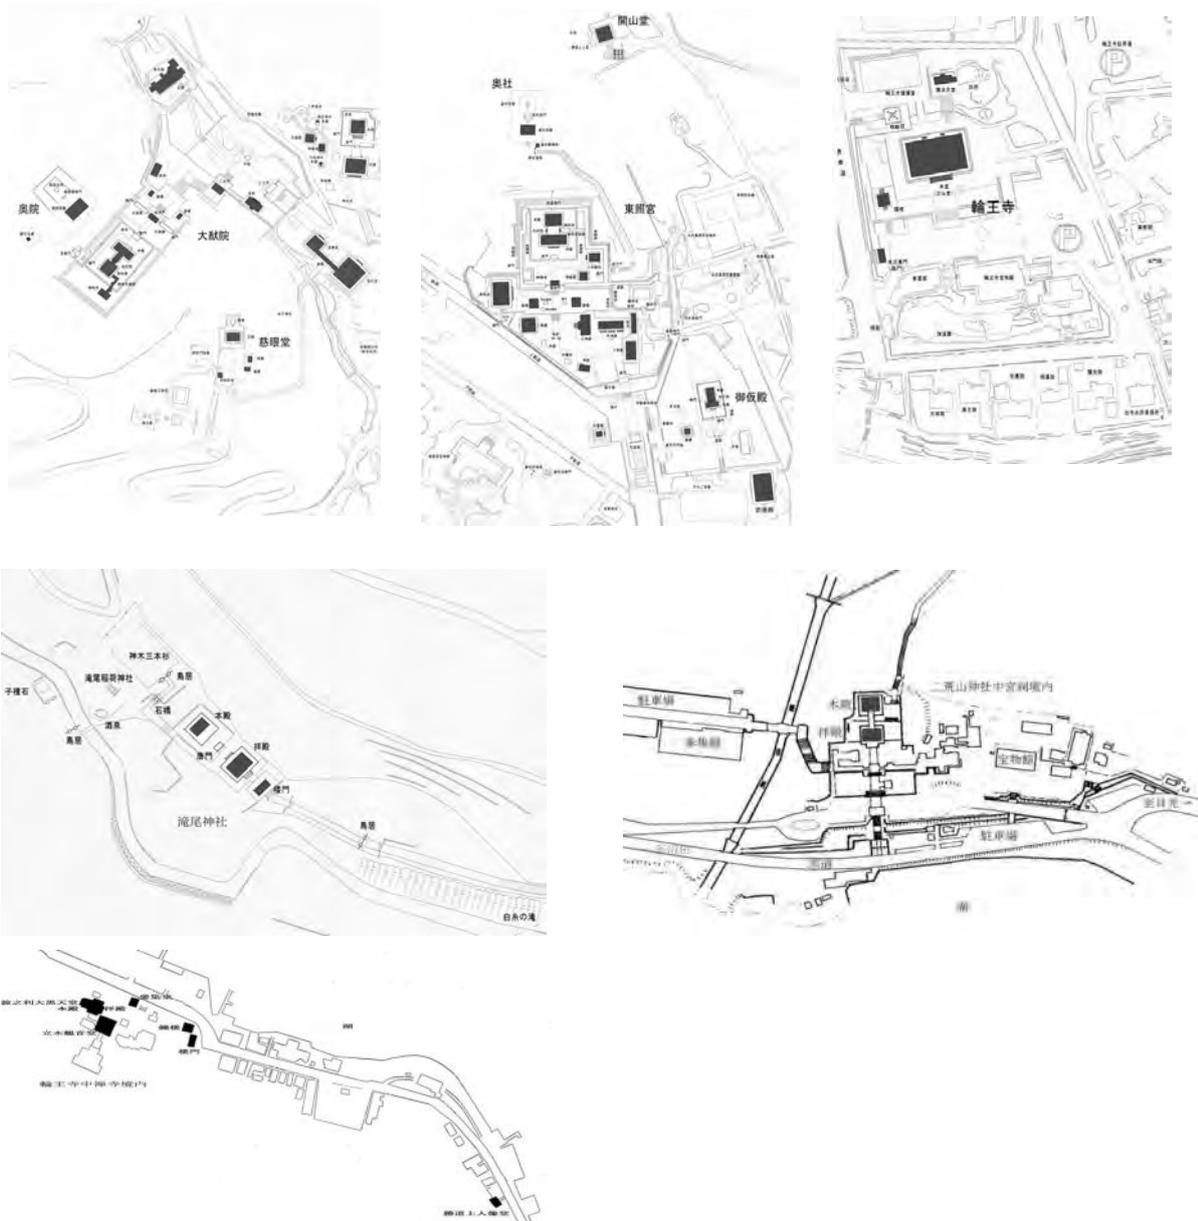
Fig. 4: Wooden historic buildings at the Nikko World Heritage site. Sticky insect ribbons were set in the structures painted black (Harada *et al.* 2010).

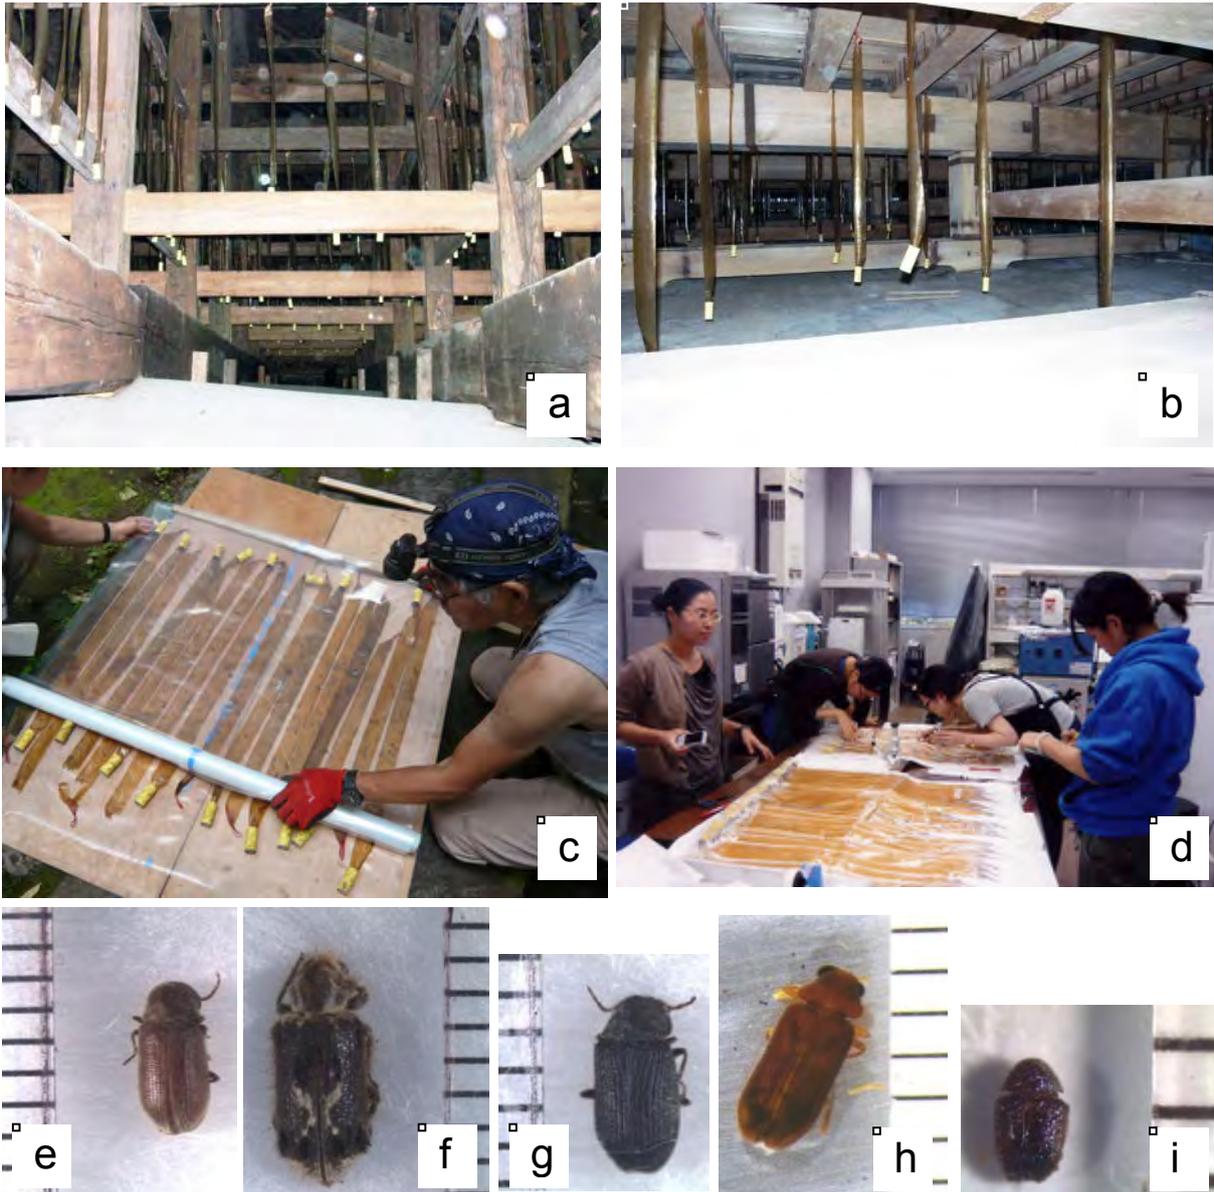
Fig. 5: Insect survey by sticky insect ribbons, and the wood-boring anobiids found by the survey. **a**: Insect ribbons set in the loft of the Sambutsu-do, Rin-nohji Temple. **b**: Insect ribbons set under the floor of the same building. **c**: Collected insect traps. **d**: Data records at the National Research Institute for Cultural Properties, Tokyo. **e-i**: Wood-boring anobiids found in the Nikko area (Komine *et al.* 2011).

All of the beetles that were stuck on the adhesive ribbons were cut off from the sheets, then grouped and identified by Yukio Komine. Five wood-boring anobiids were found in this manner in ribbons placed throughout the Nikko area: *P. cylindricum* (Fig. 5e) and a larger species, *Trichodesma japonicum* (Fig. 5f), *Hadrobregmus pertinax* (Fig. 5g), *Oligomerus japonicus* (Fig. 5f), and *Sculptotheca hilleri* (Fig. 5i) (Komine *et al.* 2011). The large anobiids such as *P. cylindricum*, *T. japonicum* and *H. pertinax* caused severe damage. We analysed the data revealing the numbers of such large and destructive anobiids species per 100 adhesive tapes (Hayashi *et al.* 2011, Hayashi *et al.* submitted), and a few buildings were found to have a significant density of these anobiids. For example, the Sambutsu-do showed significant densities of both *P. cylindricum* and *S. hilleri* that indicated active infestations by these anobiid species, and the Daiyu-in Nitenmon gate showed significant densities of *T. japonicum* and *S. hilleri*. It was concluded that both structures had significant and on-going infestations.

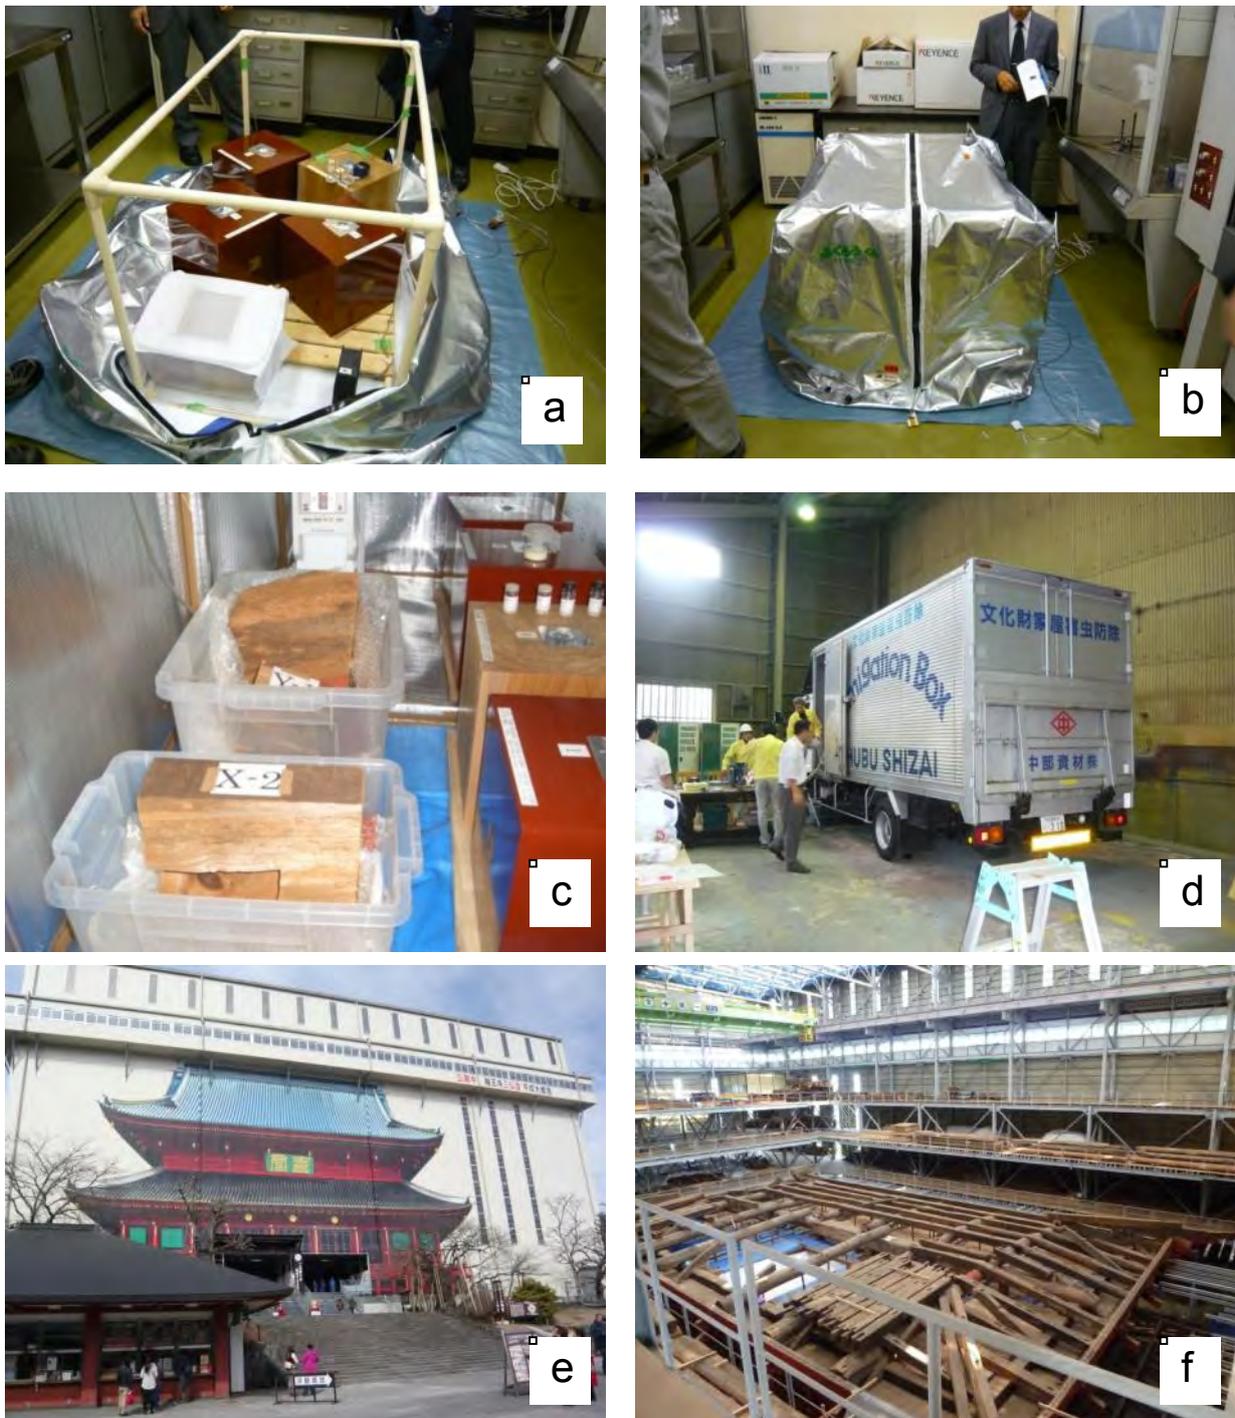
Fig. 6: Experiments to choose appropriate treatment measures and Sambutsu-do, Rin-nohji temple under recent reconstruction. **a,b**: Carbon dioxide treatment test (November 2009). **c,d**: Vikane fumigation tests (January and September 2010, respectively). **e**: Shelter building for reconstruction of Sambutsu-do (photographed in December 2012). **f**: Inside the shelter, after 1disassembly of the whole roof. Large beams are visible after the removal of the roof, viewed from upper side of the building (photographed in December 2012).

We examined the effects of two treatment options on the *P. cylindricum* using actual damaged wooden blocks from the Sambutsu-do. First, T. Torigoe imaged many damaged blocks by X-ray CT scanning, and we chose those blocks which had many insects (mainly larvae) inside. We used the selected blocks to evaluate the efficacy of fumigation with carbon dioxide or Vikane® (sulfuryl fluoride) fumigation (Kigawa *et al.* 2011). Photos illustrating the carbon dioxide treatment and Vikane fumigation are shown in Fig. 6.

We evaluated the effects of these two treatments by observing the movements of the insect larvae by repeated X-ray CT scanning after the treatments. We performed one carbon dioxide and two series of Vikane treatment tests. Table 1 shows some core results of these experiments (Kigawa *et al.* 2011). We found that the carbon dioxide treatment (60%–80% vol. of CO₂ at 25°C) and the Vikane treatment applied for more than 48 hours were both efficient to eradicate the *P. cylindricum* larvae in the

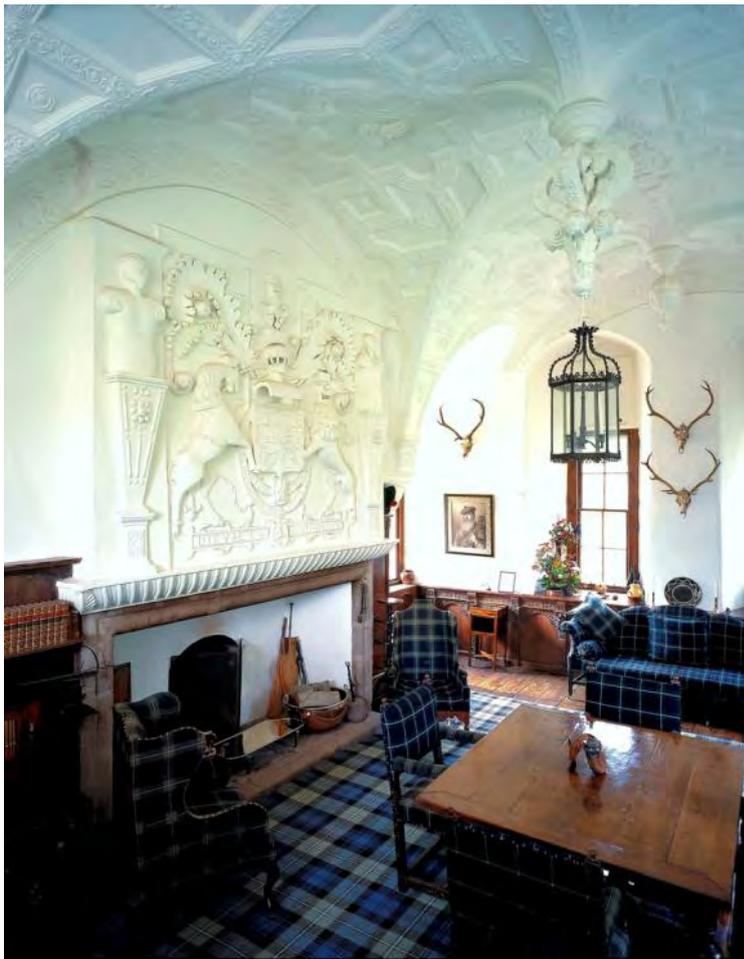
Fig. 2: Decorative plaster ceiling in The Hall. © National Trust for Scotland.

The interiors are innovative and Craigievar can boast the best moulded plaster ceilings in Scotland (Fig. 2). The collections are nationally important. Some of the furniture is thought to be original which in itself is 'exceptional in Scotland on account of its unsettled history' (NTS 2004). The majority of the rest of the collections reflect the material culture of the Forbes-Sempill family. The castle, domestic yet impressive, was very much a holiday home for the family and a crucial decision to preserve the castle's atmosphere was taken in the 1820's where 'roughing it' was part of the fun i.e. little in way of modern conveniences, like electricity supply, was therefore introduced.

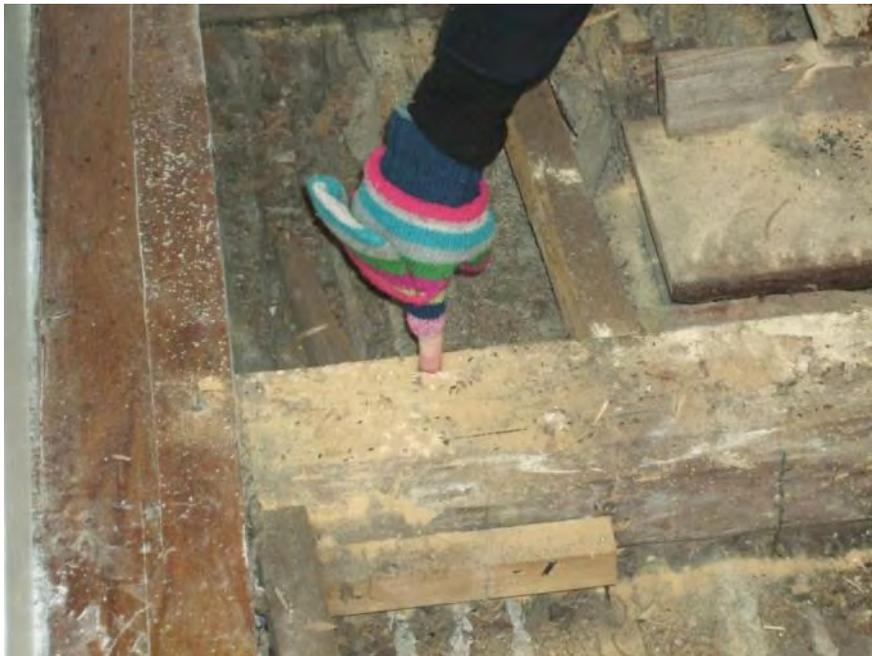
Fig. 3: Damage to floorboards caused by *Anobium punctatum*. © National Trust for Scotland.

Early indications from the 2009 and 2010 IPM data for Craigievar and verbal reports from Craigievar property staff pointed to a substantial rise in the number of adult furniture beetle found in the castle following the major eighteen month external repairs programme. The presence of an infestation was not in dispute but the rise in adult insects detected on traps (hundreds) was new. In the past the family recounted having a wormy castle and it was common practice to annually bomb the castle with a fumigation ‘treatment’. The number of beetles collected and observed in 2010 and since was alarming for property staff as was the damage to floorboards and supporting joists (Fig. 3). Collections and panelling were affected but equally concerning were the structural implications. The puzzling explosion in infestation coincided with the end of a major project undertaken to improve the condition of the building.

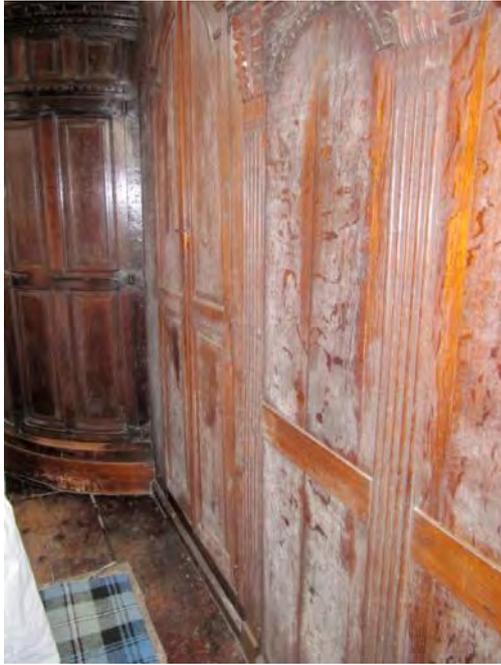
Fig. 4: Mould growth on wooden panelling, Great Hall. © Sarah Gerrish.

A major project to address this was underway by September 2007, scaffolding was erected and the castle enclosed in protective sheeting. The cementitious harling was mostly removed by hand. The castle was reharled with lime mortar and lime washed by the spring of 2009. Harling with traditional lime mortar was the best solution to manage the moisture within the structure and encourage evaporation to ensure the building walls would remain dry. However, the internal consequences of the reharl were twofold; increased beetle activity and increased mould inside the castle (Fig. 4).

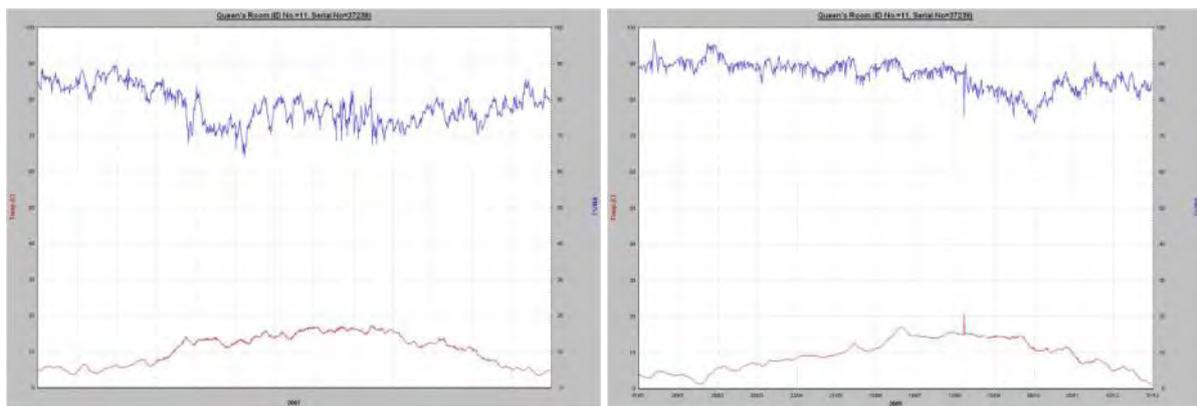
Fig. 5a & b: Environmental monitoring data graphs for the Queens Room 2007 and 2009 respectively. © National Trust for Scotland.

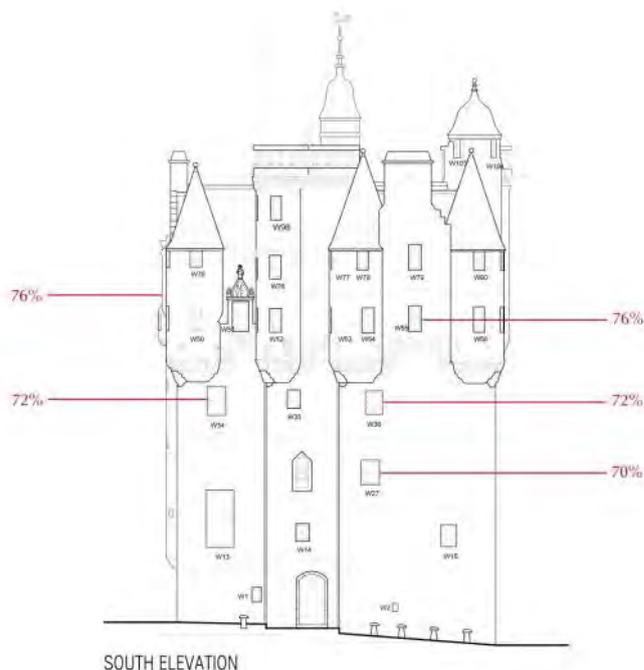
Fig. 6: South elevation of Craigievar showing RH set points for conservation heating © National Trust for Scotland.

- Graduated set points for conservation heating would facilitate increased air circulation through the castle and aid the escape of excess moisture
- Heating was to be kept to a minimum over concerns for increasing the risk from mould growth in a saturated building and the plaster ceilings were prone to efflorescence of salts
- Limited electrical service available
- Introducing warmer air in lower levels of the castle, rising to the next floor level would reduce the amount of time conservation heating would be employed and assist keeping energy consumption as low as possible.

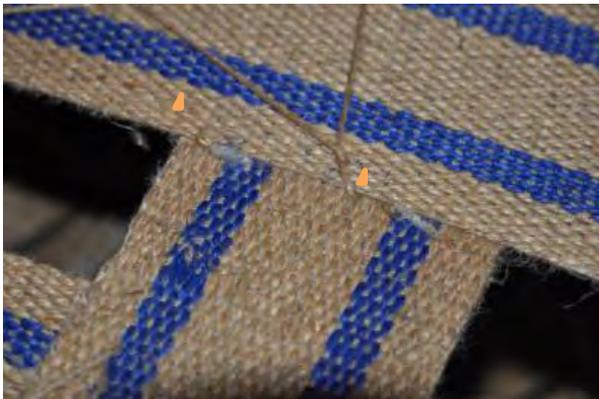
Fig. 2: Two pupate cases of the webbing clothes moth underneath a chair, discovered in the first year of monitoring.

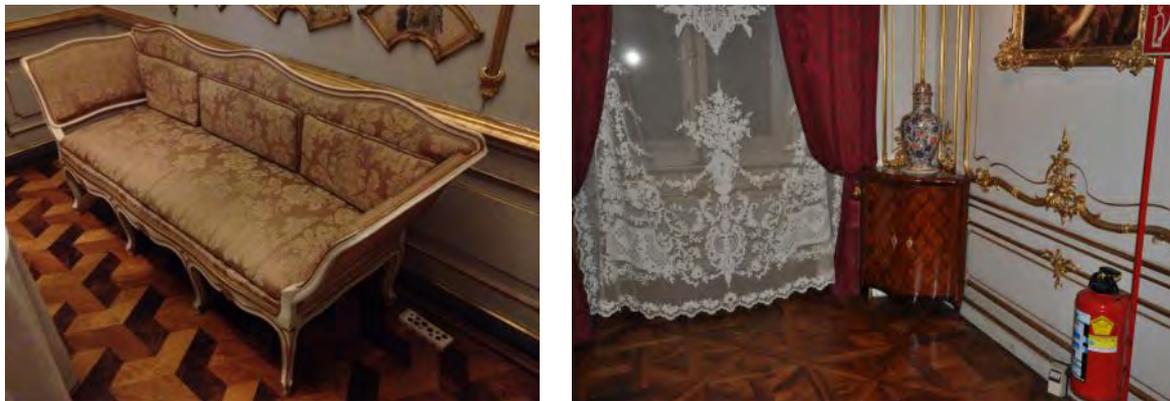
Fig. 4 a,b: Wood boring beetle infested objects.

Only very few objects, i.e. some historic furniture and a picture frame, and the wooden parquet floor in two rooms were found in the palace with an active furniture beetle (*Oligomerus ptilinoides*) infestation (Fig. 4a,b) (Hassler *et al.* 2015).

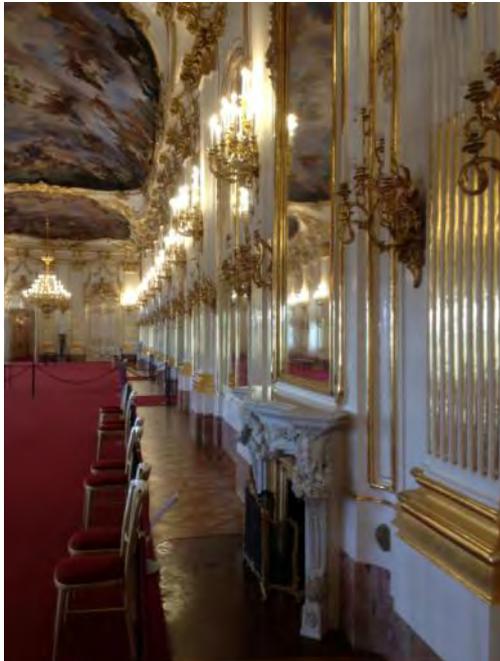
Fig. 5: Chimney in the Great Gallery where a large number of *Attagenus* beetles were found in 2013.

this problem we applied Diatomaceous earth (or ‘Kieselgur’) in these spaces and tried to improve the housekeeping. In 2013 a chimney was discovered in the Great Gallery with a large number of beetles and moths on the trap, here we found a dead pigeon in the chimney.

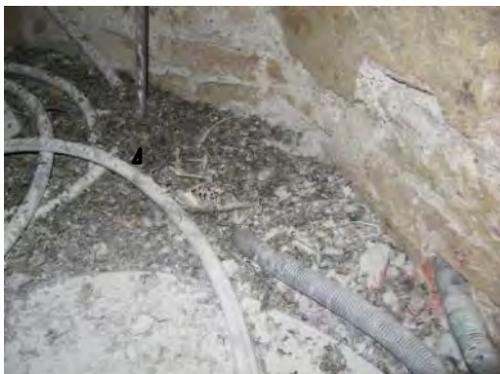
Fig. 6: Remains of a dead pigeon (circle) in an historic ventilation shaft in the Great Gallery.

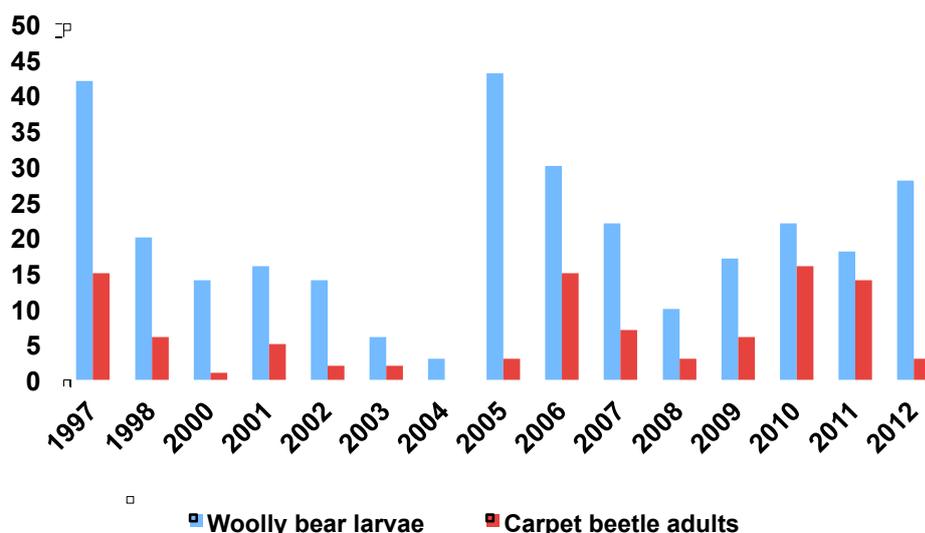
Fig. 1: Audley End House *Anthrenus* adults and larvae catch results 1997-2012.

Annual results have been gathered and recorded in this manner since 1997 providing useful trend data which has directly informed collections care practices. At Audley End, for example, the data relating to the varied carpet beetle (*Anthrenus verbasci*), webbing clothes moth (*Tineola bisselliella*), and case-bearing clothes moth (*Tinea pellionella*), flagged up issues relating to housekeeping and chimney cleaning (Fig. 1).

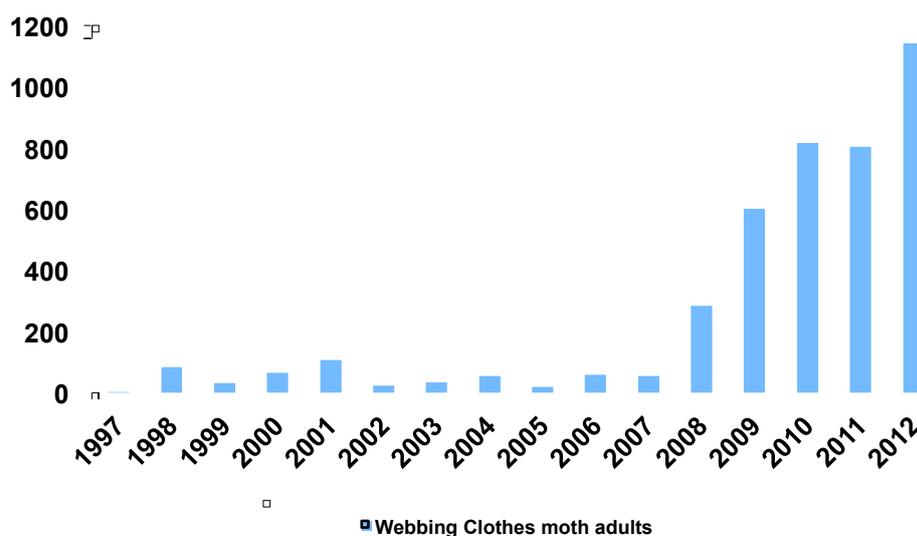
Fig. 2: EH properties *Tineola* clothes moths catch 1997 to 2012.

On reviewing the national data over the past 15 years, we have a picture of which insect pests are most likely to be found in our historic properties and are on the increase. Looking at the results for webbing clothes moth (*Tineola bisselliella*), numbers have increased sharply since 2008 (Fig. 2). The introduction of more effective moth pheromone lures in 2008 explains an increased catch but they cannot account for the steady increase in numbers since then. With the annual trap numbers of other species remaining at steady levels, the increase in numbers of clothes moths being caught currently presents the greatest potential risk to EH collections.
