**Integrated Pest Management (IPM) in
Museums, Archives and Historic Houses -
Proceedings of the International
Conference in Vienna, Austria 2013**

Distribution of wooden-damaging beetles captured by adhesive traps in historic buildings in

Hayashi, Mikiko; Kigawa, Rika; Harada, Masahiko; Komine, Yukio; Kawanobe, Wataru & Ishizaki, Takeshi

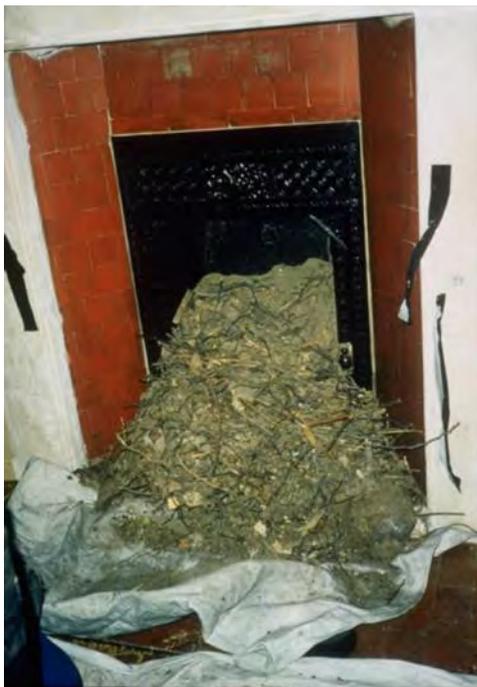
Fig. 3: Fireplace clean in the Duke of Wellington's Room, Walmer Castle, Kent, UK.

Chimneys, which are nearly always found in EH sites, are the principal source of significant rises in moth species. Dead birds and their nests trapped in chimney flues are a natural habitat for Tineid moths and Dermestid beetles larvae that can fall down into the fireplaces and lead to an infestation within the building. Chimney flues have been largely missed from cyclical maintenance schedules as they are no longer used, but this situation has changed at EH through the IPM programme and chimney cleaning and effective capping is now recognised as a core maintenance activity (Fig. 3).

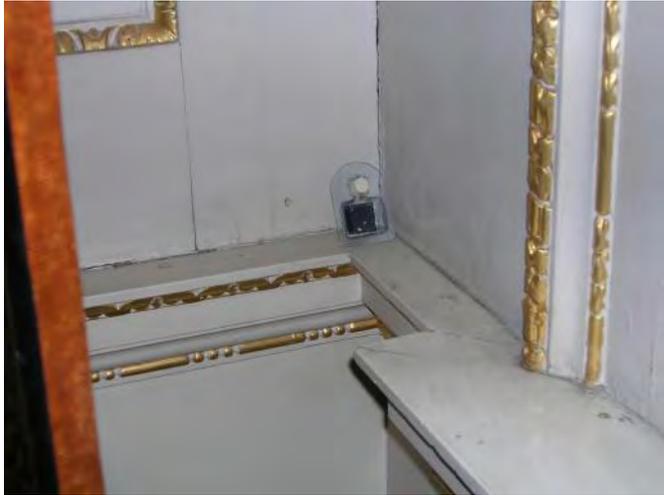
Fig. 4: An Exosex CL dispenser and pheromone lure in the Great Room at Marble Hill House, London, UK.

Following the successful trials of Exosect Ltd's Exosex CLM and CL moth confusion pheromones lures at Marble Hill House in London since July 2007 (Lauder 2009), we can now consider deploying it at other sites to control webbing clothes moths numbers to acceptable levels. This is a non-chemical 'pest confusion' treatment designed specifically to reduce the numbers of the highly destructive larvae of the webbing clothes moth. Each pheromone lure tablet uses a synthetic female pheromone to attract male clothes moths into a dispenser where the 'Entostat' powder combined with the pheromone is situated. Males are lured to the dispensers and upon contact with the powder; it coats their bodies (Fig. 4).

The senses of the coated moths are overwhelmed and they cannot detect females as a result. As they leave the dispenser, they then attract other male clothes moths and so spread the confusion effect even further. Female moths do not mate, lay very few fertile eggs and as a consequence there are far fewer larvae produced. The twenty-four lures currently dispensed around the house are changed every eight weeks. Since 2006, when thirty-six webbing clothes moths were caught on sticky museum traps situated around the house, the numbers have since have depleted to only four moths being caught in the house in 2012 (Fig. 5).

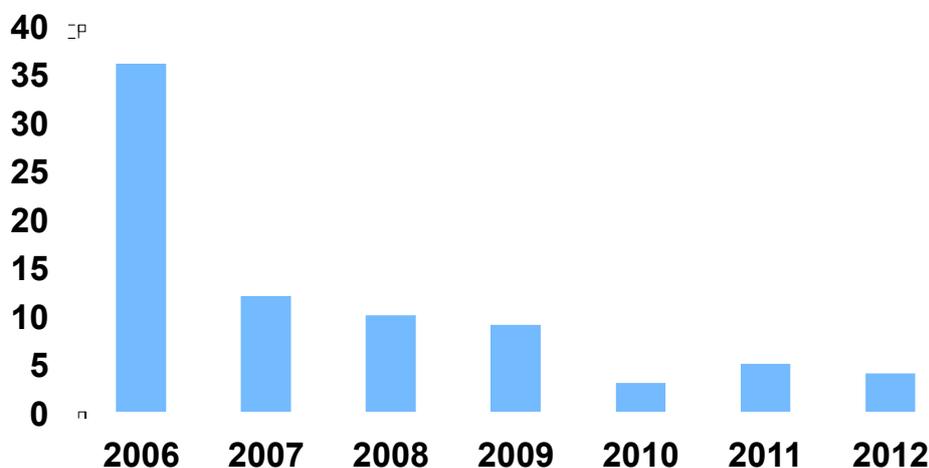
Fig. 5: Marble Hill House *Tineola* clothes moths catch 2006-2012. For each quarterly return in 2012, 24 Exosex CL lures, 5 low-dose bullet lures and 27 blunder traps were used.

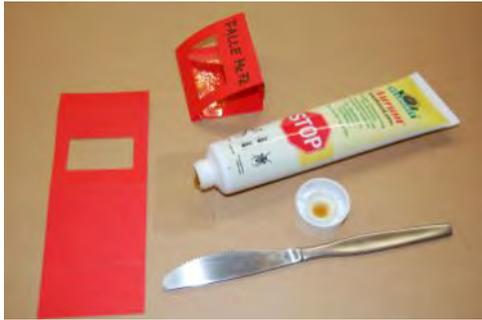
Fig. 2: Self-made sticky trap. Fold the cardboard. Apply adhesive on a transparent foil. Clip it together.

In order to avoid problems with identifying beetles that lie backwards on the trap, transparent foil was applied, which can easily be turned when the insect is upside down. We experimented with different adhesives and tried a number of attractants, including vanilla, ketchup, and butter. An adhesive was chosen that is common in fruit-growing and very inexpensive; no further attractants were added. The foils are renewed on a yearly basis to ensure that the traps are sticky enough to trap insects (see Fig. 2).

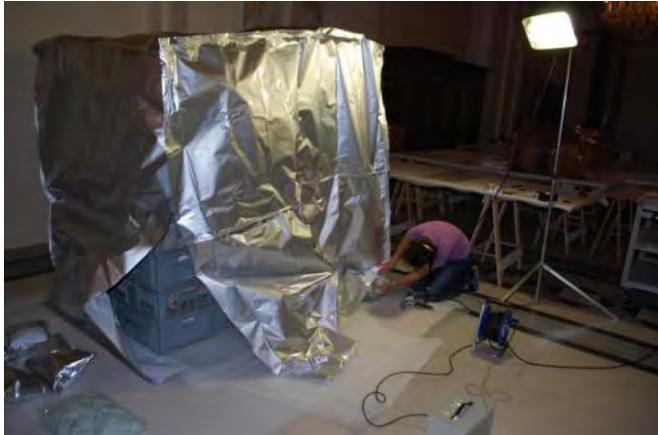
Fig. 3: Large tent used for anoxia with oxygen scavengers. We do not use such big volumes anymore; the smaller plastic foil bags are more effective with oxygen scavengers.

foldings and bents in the metal component of the gastight foil had developed into cracks (giving the impression of a starlit sky when looking up from the inside). Indeed, this type of tent is suitable only for the use with nitrogen, but not with oxygen scavengers.

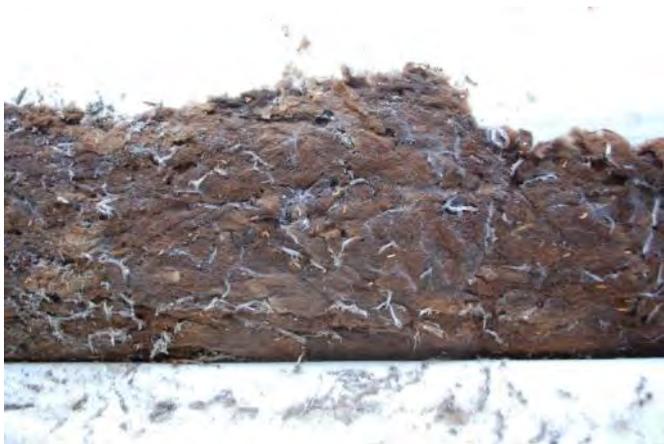
Fig. 4: This felt-carpet was preventively pest treated but not cleaned on its return from an external storage in 2007. When we opened the cover of the object in 2013 we were not sure, whether the textile was infested again. So we had to treat the felt carpet again.

If insect remains are found on an object after previous pest eradication it is unclear, whether or not the object is subject to a re-infestation (Fig. 4). In addition, dead insects are good food for other pests. Therefore, it is important to clean the objects after every pest eradication treatment. We clean the objects with special medical vacuum cleaners under the guidance of our conservators.

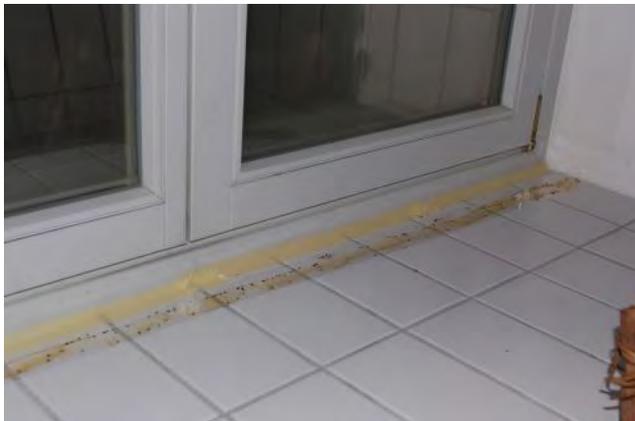
Fig. 5: Sticky barrier made out of a long transparent foil. With this barrier lying underneath a window, we can detect how many insects are attracted by the natural light outside. Adult *Trogoderma angustum* on the strip.

Sometimes, when we cannot identify the source of infestation we set up sticky barriers for detecting the way insects are moving. This happened in the course of a large *Anthrenus* larvae attack at the so-called 'Melanesia storage' in 2006. Only after installing a grid of sticky barriers we realized that all insects entered through a small door, outside of which a dead pigeon was lying in a ventilation shaft. After removing the source of infestation, the door was sealed properly and a pigeon net was installed over the ventilation shaft. The floor of the store was cleaned thoroughly, including the spaces under the selves. We did not treat any objects, because we found only larvae but no adult insects. Following these measures no further insects were found in this storage area.
