Pest Monitoring Case Study: Pinpointing a Clothes Moth Infestation at the Denver Museum of Art Christina Cain

Overview:

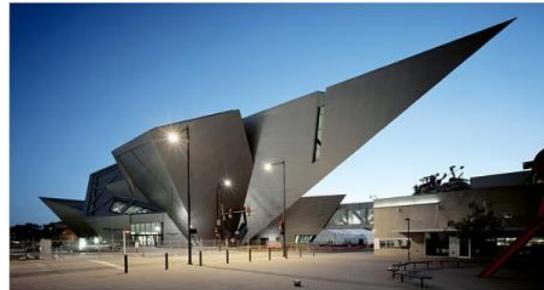
In 2006, the Denver Art Museum was in the completion phase of the new Libeskind-designed Hamilton wing of the museum. With one end of the building finished, art installation began in a temporary gallery space. Soon it became evident that some sort of pest issue was at hand. Installers were frequently spotting webbing clothes moths flying around the gallery. After three months of monitoring the problem, a dead pigeon was found behind the drywall. After extraction, the moth infestation immediately ended.

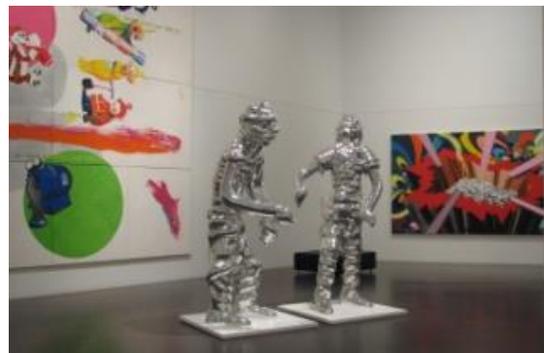
The new wing of the Art Museum was not yet complete when the installation of art began. It was known that there had been birds, mice, squirrels and even a cat inside the building during construction. Also, the construction workers were not prohibited from eating inside the building. Temperature and humidity controls were functional in the completed portions of the building, piping in up to 45% humidity and maintaining 68 degrees Fahrenheit. Installers began noticing small gold moths in the temporary gallery almost immediately. At this point there was already art in the room, though none of it contained any protein material likely to attract the moths. The museum's IPM expert was notified and implemented a daily monitoring program.

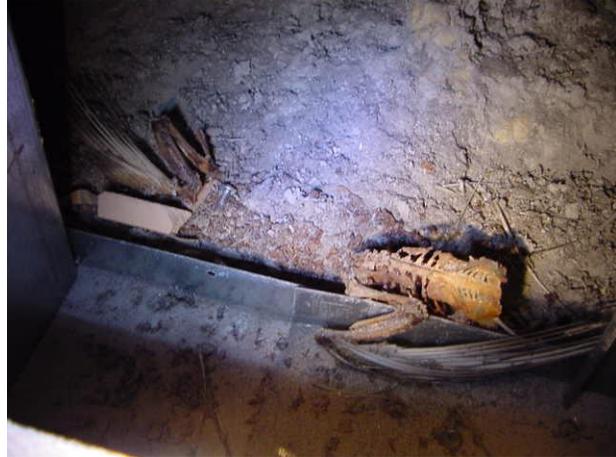
The painting on this wall (a 15 panel piece) was removed two times to ensure that the infestation was not present inside the stretchers. No evidence of larvae, damage, webbing or eggs was found, though adults were found on the wall behind the painting. This particular wall is jagged, with the protruding section being the most affected. Just to the side of this was a fire extinguisher box inset into the wall. The box was removed for an inspection of the inside of the wall. Though moth carcasses were found inside this section, no live specimens were recovered. This confirmed, however, that the infestation was coming from inside the wall. It was decided to penetrate the wall just behind the painting and use a scoping camera to inspect the area. A plumber was hired to bring his camera and monitor. The hole was cut above the ceiling tiles to prevent dust and wall damage near the art. All art was covered and permission from the art owners was secured before the process began. As the camera slowly descended toward the floor, the culprit came into site. After an adjustment to the camera location, it was determined that the source of the infestation was a dead bird just behind the drywall.
